# IDENTIFICATION OF RISK AND COSTING OF PROTECTION FOR THE HUERFANO COUNTY WATER CONSERVATION DISTRICT (HCWCD)

**Enginuity Engineering Solutions, LLC (Enginuity)**  
10106 W. San Juan Way, Ste 215

**Huerfano County Water Conservation District**  
(HCWCD)

June 2022

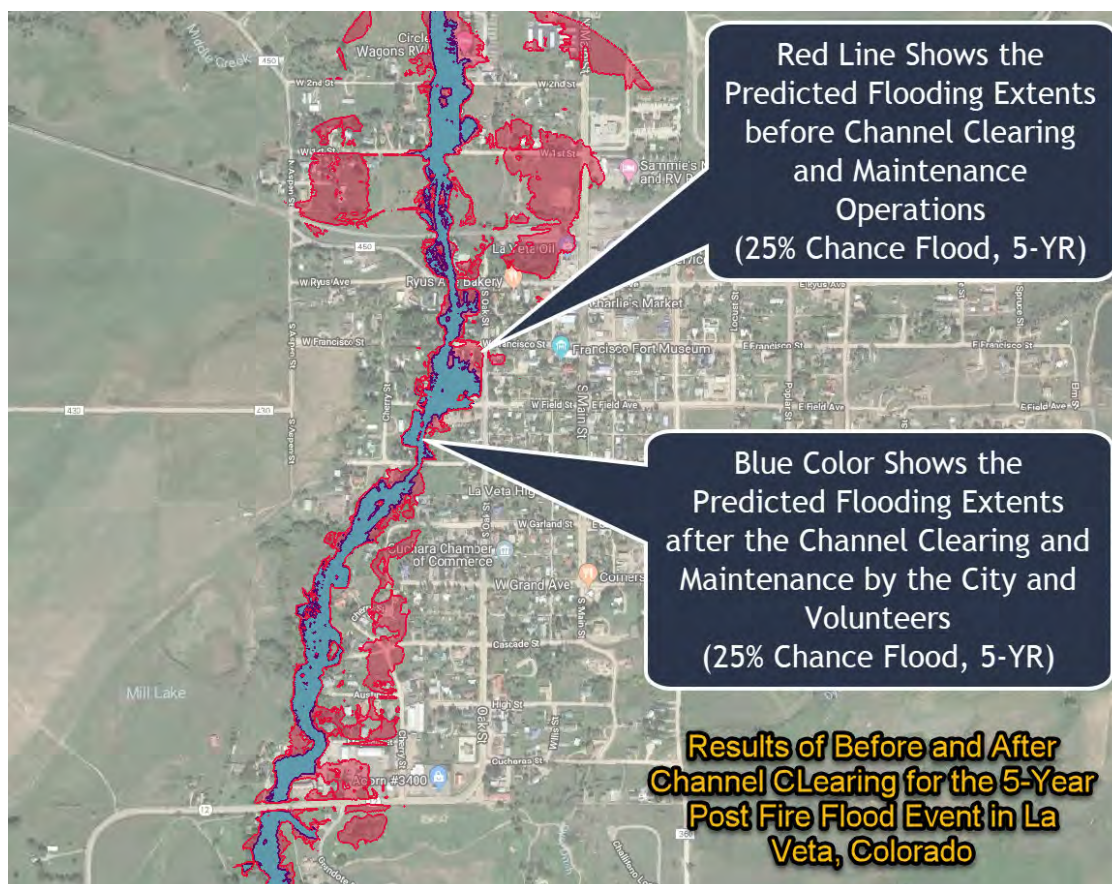
Figure 1 - Image of Before and After Cleaning Operations of the Cucharas River

- a. Request funds for or budget for cleaning and working areas around the flood warning gages.
- b. Requests funds for or budget for work to keep the main river corridors through the Town of La Veta and Huerfano clean of brush, large trees, snags, and blockages.

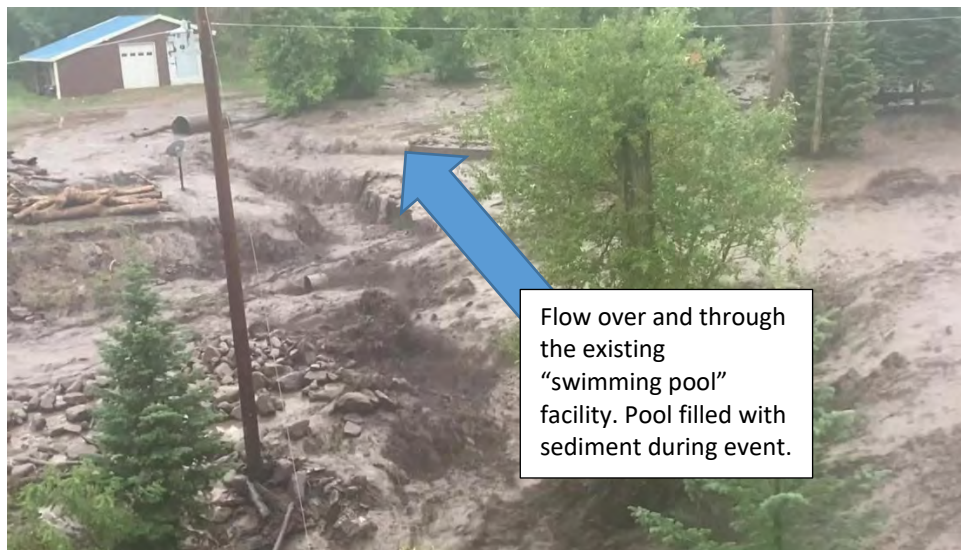
Two intense rainfall events occurred over the Spring Creek burn area, specifically the Indian and Middle Creek watersheds on July 26<sup>th</sup> and August 3<sup>rd</sup>, 2020. Gage readings on Indian Creek measured depths of up to 6.4 feet on July 26<sup>th</sup> and 6.2 feet on August 3<sup>rd</sup>. Approximate flows based on the stage-discharge rating curve at the gage were 7,210 cfs and 6,420 cfs. It is noted that the gage is only an approximation of flow and is not calibrated on a regular basis. These flow rates are in the range of the 100-year event for the watershed. The flows resulted in significant damage, sediment transport, and debris flows through both creeks.

Figure 3: Flooding, sediment, and debris flow on Indian Creek on August 26, 2020.

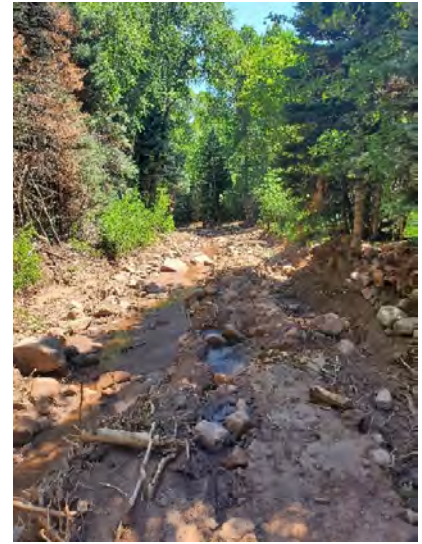
In the upper portion of the Indian Creek watershed, just downstream of the confluence with Price Canyon the channel suffers from significant debris and sediment flows. The channel itself is highly vegetated with trees that can act as debris catchers, resulting in water leaving the primary channel with overflows traveling down the forest access road. The road has suffered significant damage and is generally impassable. To address this problem, we have suggested two actions:

Figure 4: Forest access road damage near UTR.

1. Regrading the roadway to create a high point just west of the UTR access to push water into the main channel.
2. Clearing the channel downstream of the UTR access to increase conveyance, decrease debris snags, and limit flooding of the forest road.

These improvements were discussed in the field and should improve flooding conditions on the forest access road and improve conveyance through the reach.

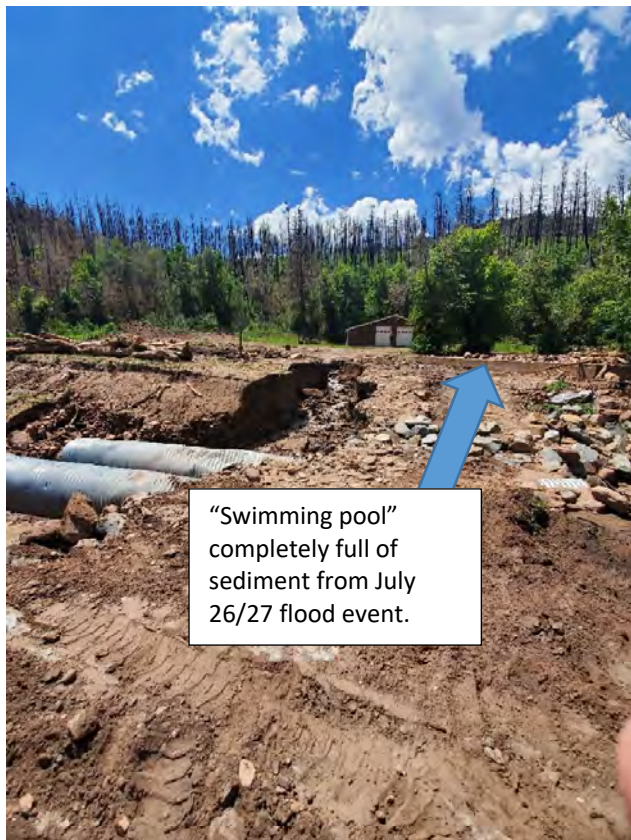
ARWC had previously repurposed an existing “swimming pool” to act as a sediment and debris trap. During the event on July 26/27 the pool facility filled in completely with sediment and debris. It is recommended to continue to clean out the pool and make the area available for additional sediment storage for future events. Some channel grading and modification may be needed upstream to redirect water through the pool while also allowing primary flows to go around the sediment trap.

Figure 5: Looking up at the downstream edge of the "swimming pool" facility following the flood event of July 26.

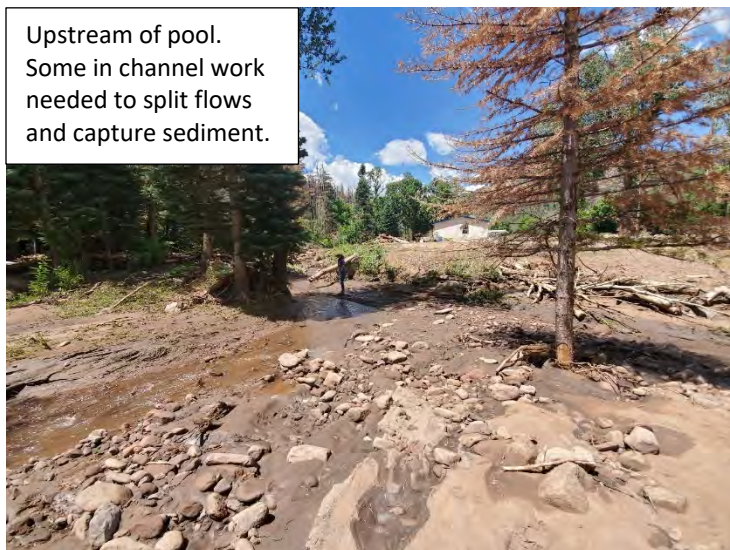
Figure 6: Channel upstream of "swimming pool".

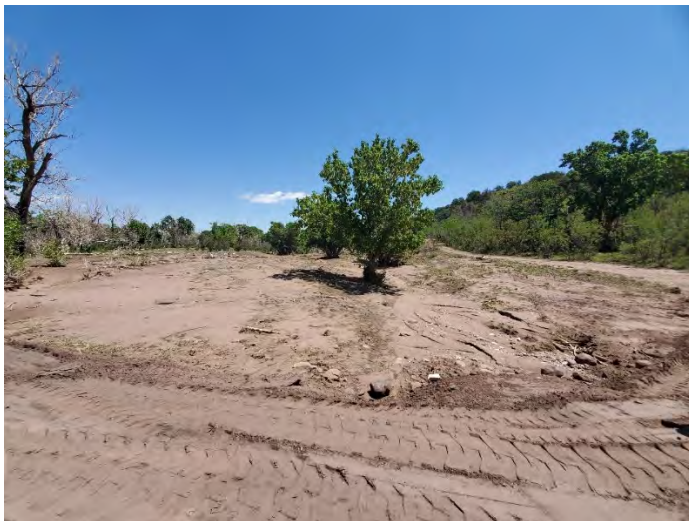
At the existing Indian Creek warning gage site, flood flows have reshaped the channel and have overflowed the channel banks. There is opportunity to catch debris and sediment in the overflow channel that exists on river right. Suggested improvements at this site include:

Figure 7: Looking downstream from gage site at existing overflow channel (river right).

1. Reconfigure gage area to ensure flows are being measured correctly. This may require some large sandbags to keep flow in the channel through the gage.
2. Downstream of the gage, debris catchers using large wood or other materials could be installed in the overflow. These would act to catch sediment and debris on the overbanks of the channel.
3. In-channel improvements may be needed to prevent further incision and downcutting in the main channel. This would also allow for more frequent activation of the overflow channel. In-stream structures could include rock-riffles or small Temporary Wood Grade Structures (TWGS) with vertical posts and woven willow stakes or wood and debris to act as sediment traps and small grade control structures. It is recommended these structures not be taller than 1.5 feet in height.

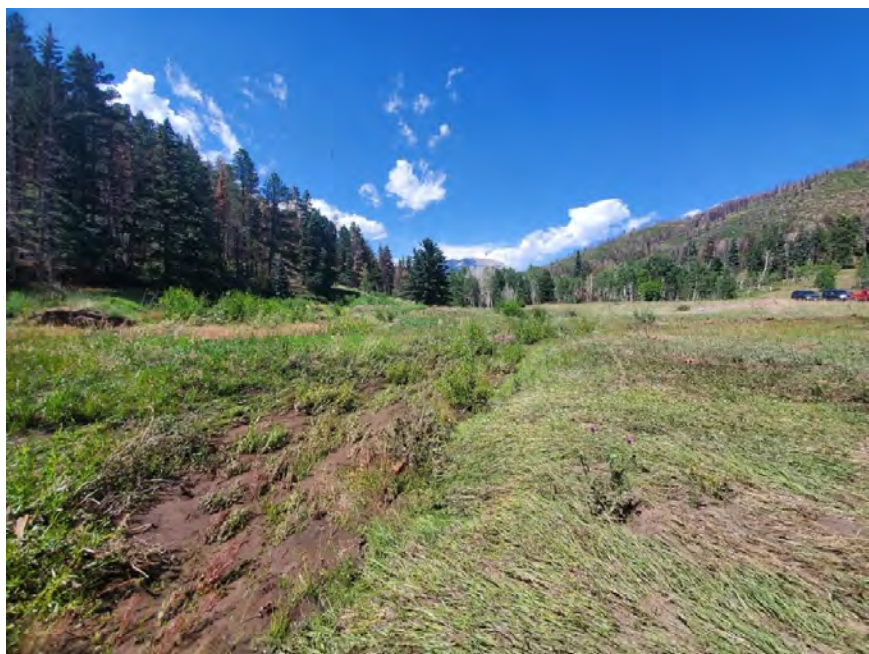
In the upper reaches of South Middle Creek, this project site sees regular flooding due to upstream burn scars. Recommendations for this site are:

Figure 8: Looking downstream along South Middle Creek at Dahmer Fields

1. Installation of TWGS to capture sediment and debris, maintain the channel thalweg, and activate the floodplain for additional sediment and debris capture.
2. Installation of some sediment/debris capture structures on the floodplain overbanks.

Given that the site is not in near proximity to any structures, is located high in the basin, and has significant floodplain available for storage of sediment and debris, these improvements appear to have a high probability of success in limiting delivery of sediment to downstream reaches. TWGS should be carefully evaluated considering their hydraulic function to appropriately key in structures and create roughness and complexity on the overbanks to flow velocities and capture materials being transported in flood flows.

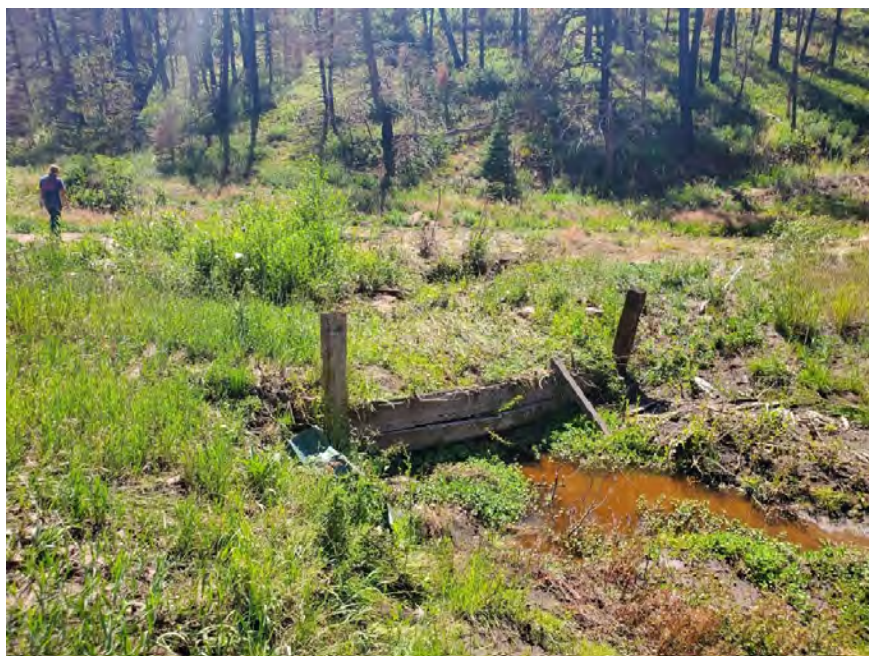
Figure 9: Existing wood check structures along South Middle Creek at Dahmer Fields.

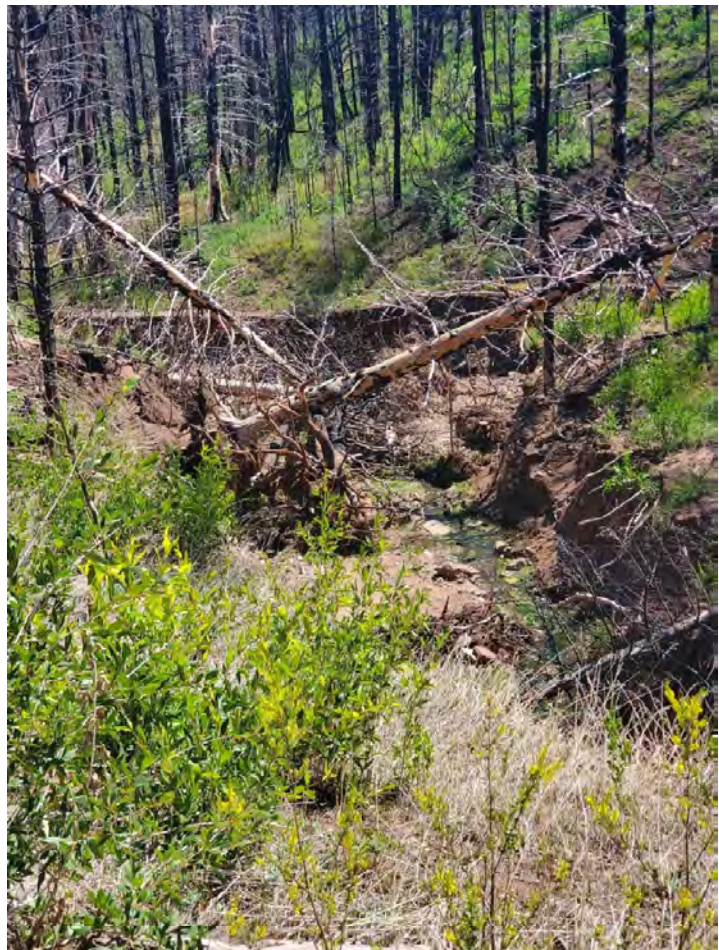
At the Idlewild site on North Middle Creek, the channel is suffering extreme erosion and downcutting due to increase flows from the burn scar. The channel is also widening as it continues to evolve. Other reports have proposed sediment capture features and stream stability improvements for this reach. Capturing sediment at this location will protect downstream road crossing improvements implemented via the NRCS EWP program. A variety of options could include large wood jams, TWGS, or rock riffle grade structures built to capture sediment upstream of the structure crest.

Figure 10: North Middle Creek at Idlewild

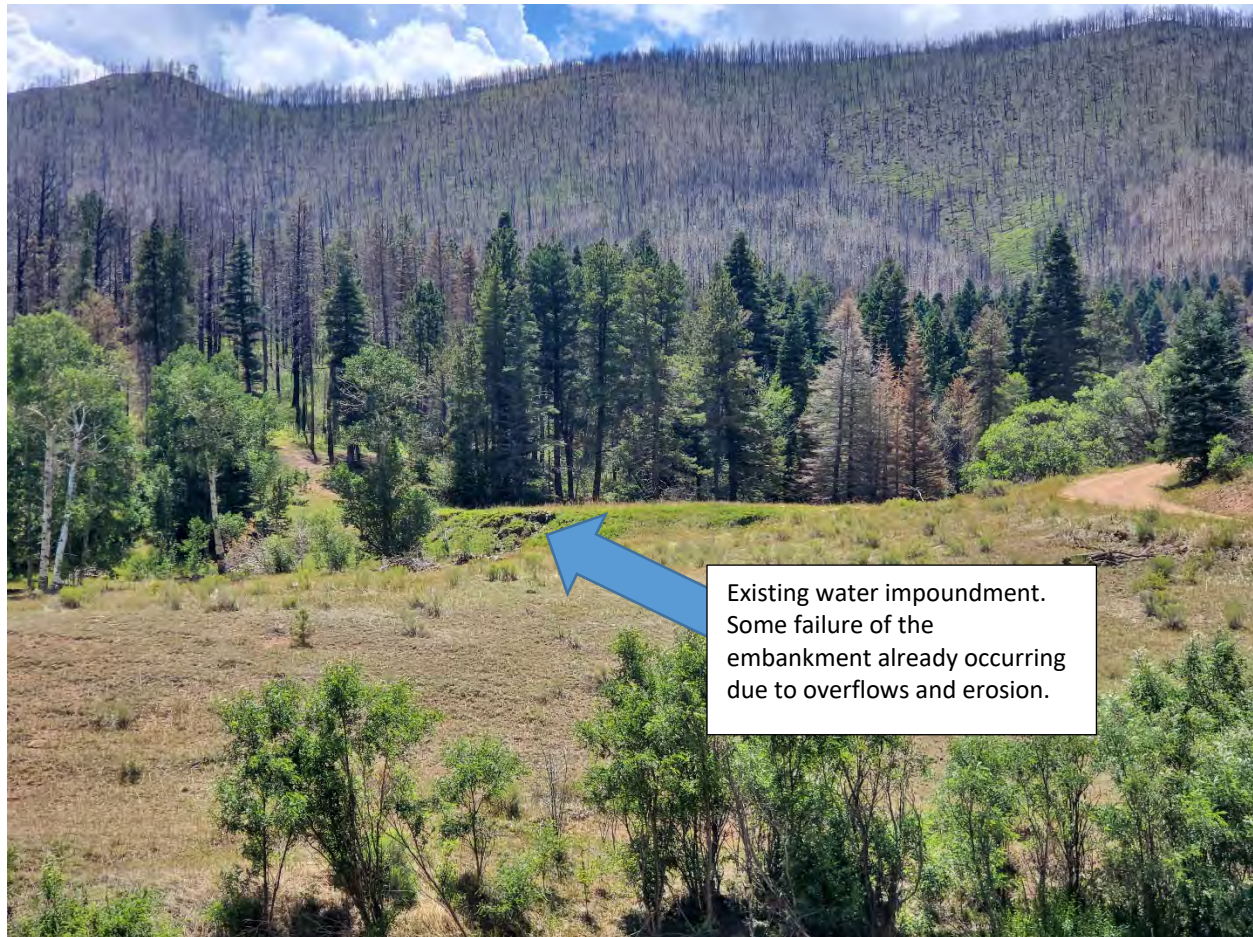
PROJECT SITE: LOWS EARTHEN DAM REPURPOSE, NORTH MIDDLE CREEK  
Above the previously implemented Goofy Calf project on North Middle Creek there is an existing water impoundment on the Cashedette sub-drainage. The existing pond embankment is suffering from damage due to the impoundment filling with sediment and experiencing overflows. Other reports have proposed to clean out and repair the impoundment to act as a sediment trap for future runoff events, limiting sediment delivery to North Middle Creek. Before implementing this improvement, the impoundment failure and potential life safety and property damage due to a failure should be considered. An adequate emergency spillway

**Figure 11: Existing water impoundment on tributary to North Middle Creek.**

would be needed and the embankment itself would need to be evaluated for stability, toe drainage, and dam safety issues. Additionally, sediment yield from the upstream drainage area should be considered as well as maintenance actions and responsibilities. An engineering feasibility study would prove useful at this location to better determine the benefit of the proposed actions.

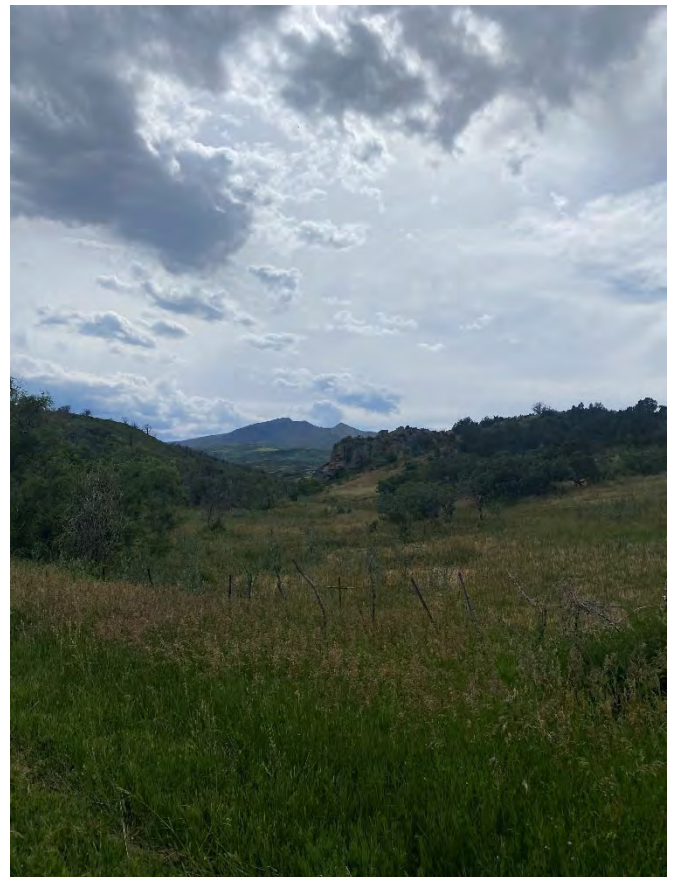
A site visit to Rilling Creek was conducted as some increased runoff has still been noted on the highway. Before the fire, hydrologic estimates indicate that 40 cfs could be expected if a storm sat on top of the 7 square miles of Rilling Creek the larger 70 square miles of Cucharas River. Due to attenuation of flows from the Cucharas, 40 cfs was the approximate annual peak estimates for a storms on either watershed as the direct runoff from a storm over Rilling Creek controls the peak.

The post fire estimates are significantly higher. The post fire after 4 years of recovery increase the 40 cfs to 137 cfs.

Figure 12 - Picture of Rilling Creek Downstream of Highway 12 (2022)

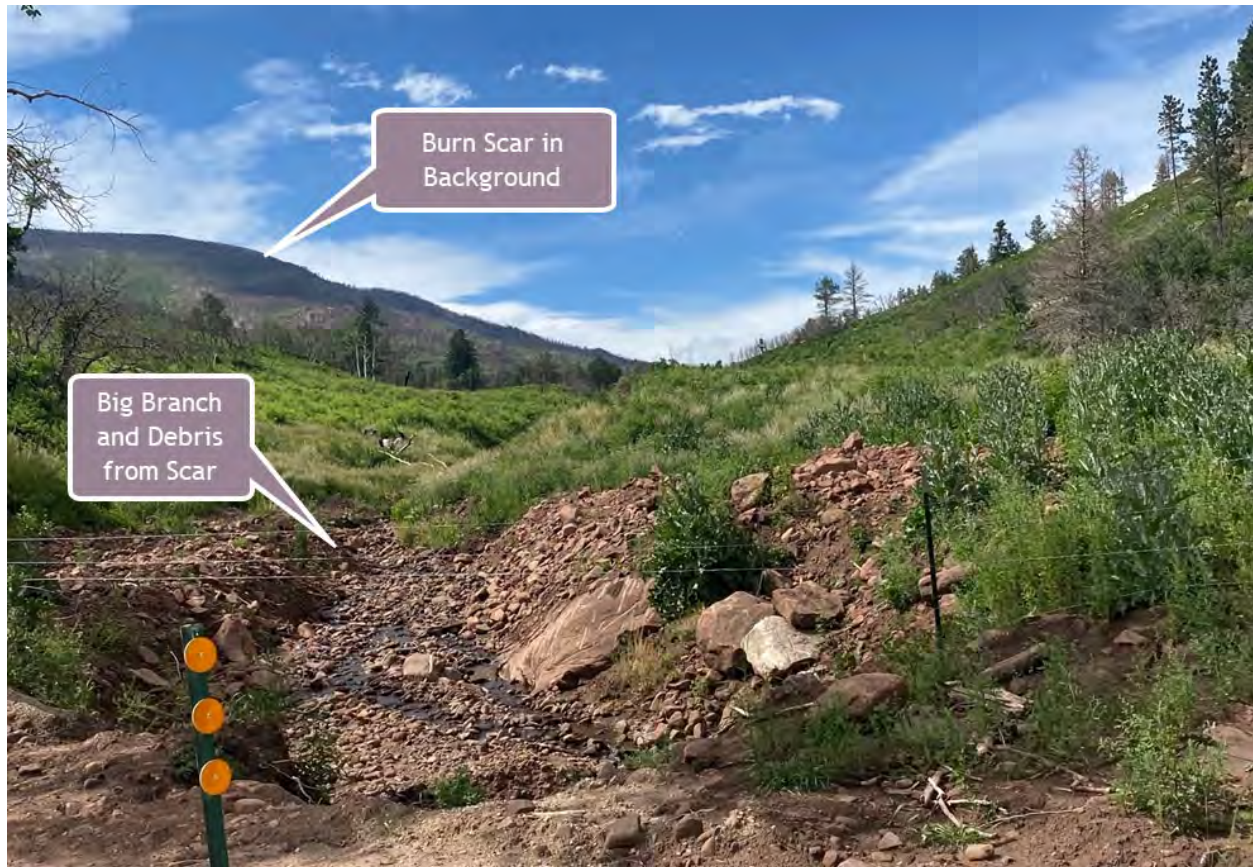
A site visit to Big Branch Creek was conducted as there have been complaints of debris loading onto the highway, long after the 2018 burn. The photo below is a picture of Big Branch upstream of Highway 12 in 2021. Although the flow

estimates are lower on big branch the increases from the fire are high. An estimated change from an annual peak of 2 to 3 cfs are increased to 20 to 30 cfs of flow and debris from the burn scar.

Figure 13 - Picture of Big Branch in 2022
