# IDENTIFICATION OF RISK AND COSTING OF PROTECTION FOR THE HUERFANO COUNTY WATER CONSERVATION DISTRICT (HCWCD)

**Enginuity Engineering Solutions, LLC (Enginuity)**  
10106 W. San Juan Way, Ste 215

**Huerfano County Water Conservation District**  
(HCWCD)

June 2022

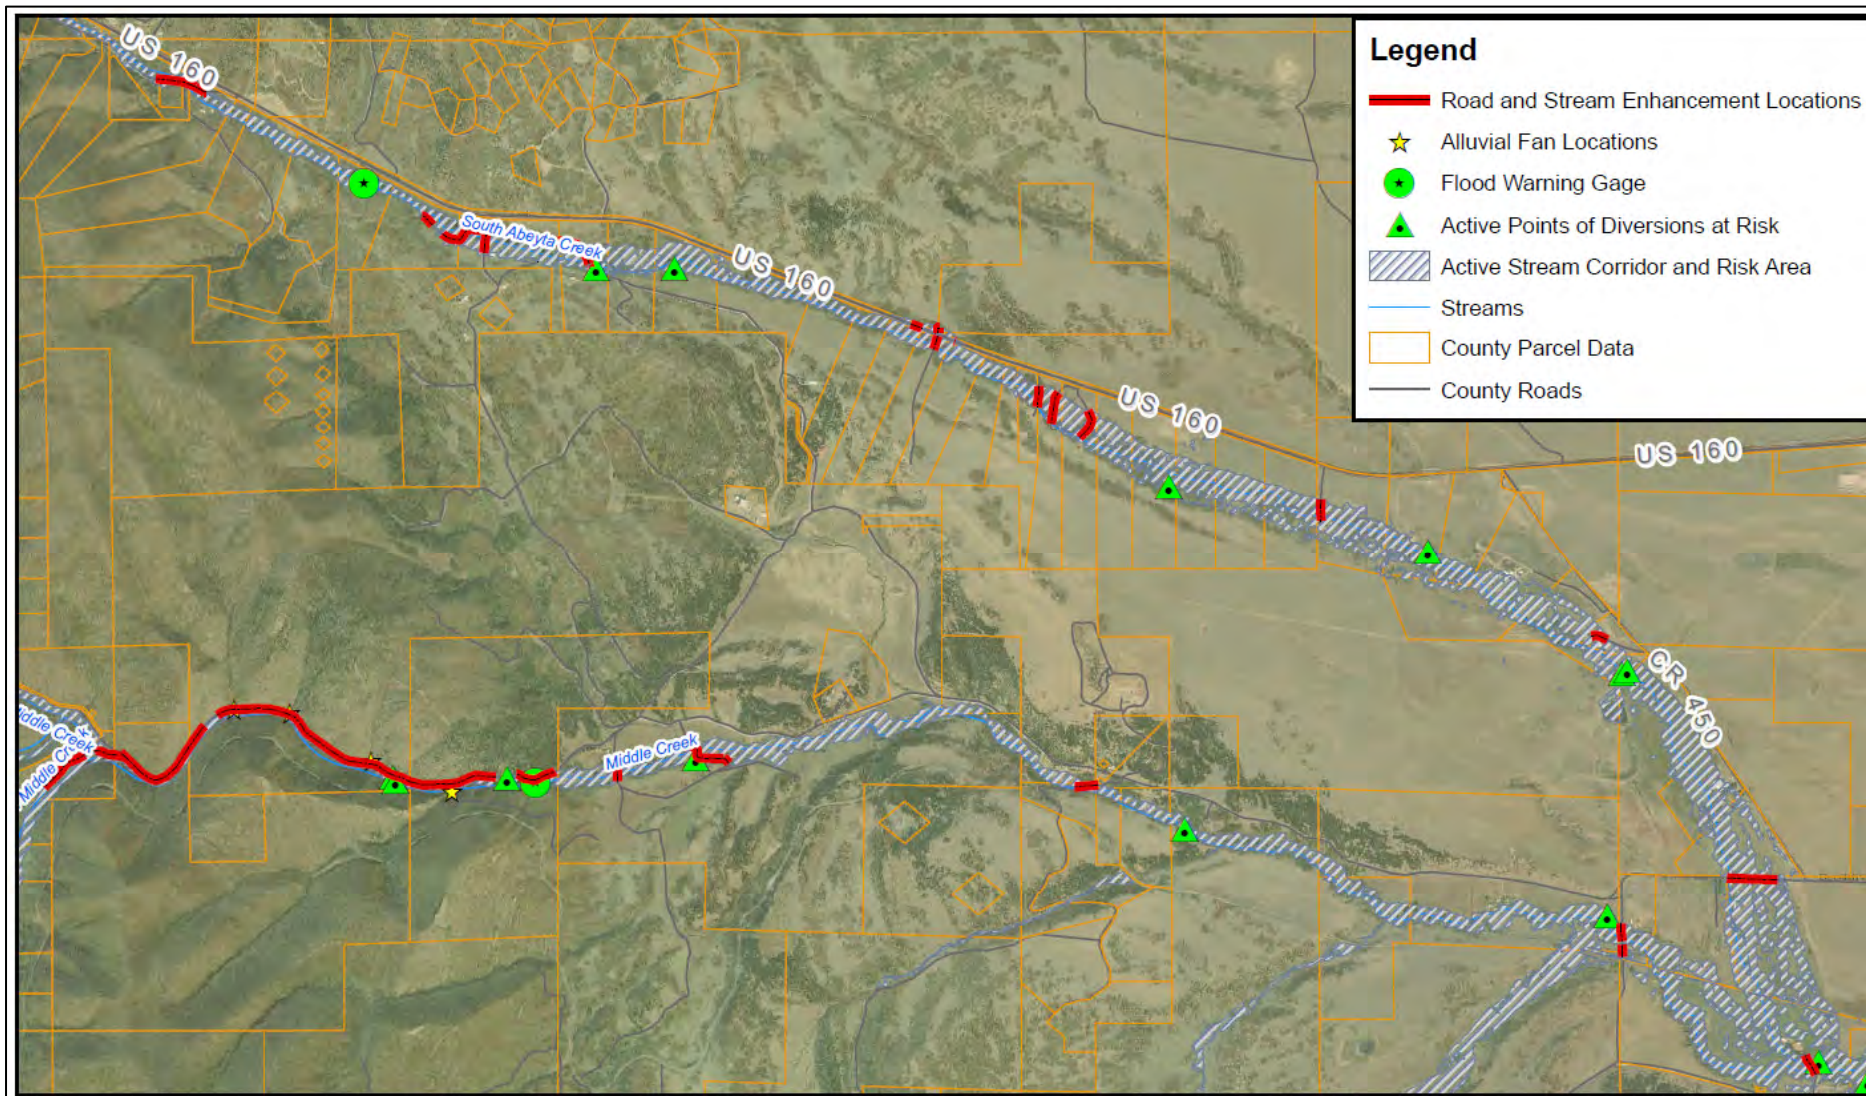
Figure 15 – Image of the South Abeyta Creek Improvement and Enhancement Locations

South Abeyta Creek is the northern most tributary that contributes to Middle Creek, and ultimately the North Side of La Veta. There are numerous low water crossings that are used to access private property. There are also sections of road embankment that are near the Active Stream Corridor (ASC) and are at risk of erosion. It does not mean that it is imminent that those sections will fail, it only means those sections are at higher risk. If all potential improvement were to be addressed, the preliminary cost estimate is in the range of 2.8 millions dollars. Table 2 and Figure 15 below is a break down of the cost estimate for this stream reach and a figure presenting the locations identified as part of this study.
