ARWC Idlewild Canyon Post-Wildfire Implementation Project Channel and Hillslope Work Map 2021

Idlewild Channel Work Treatment

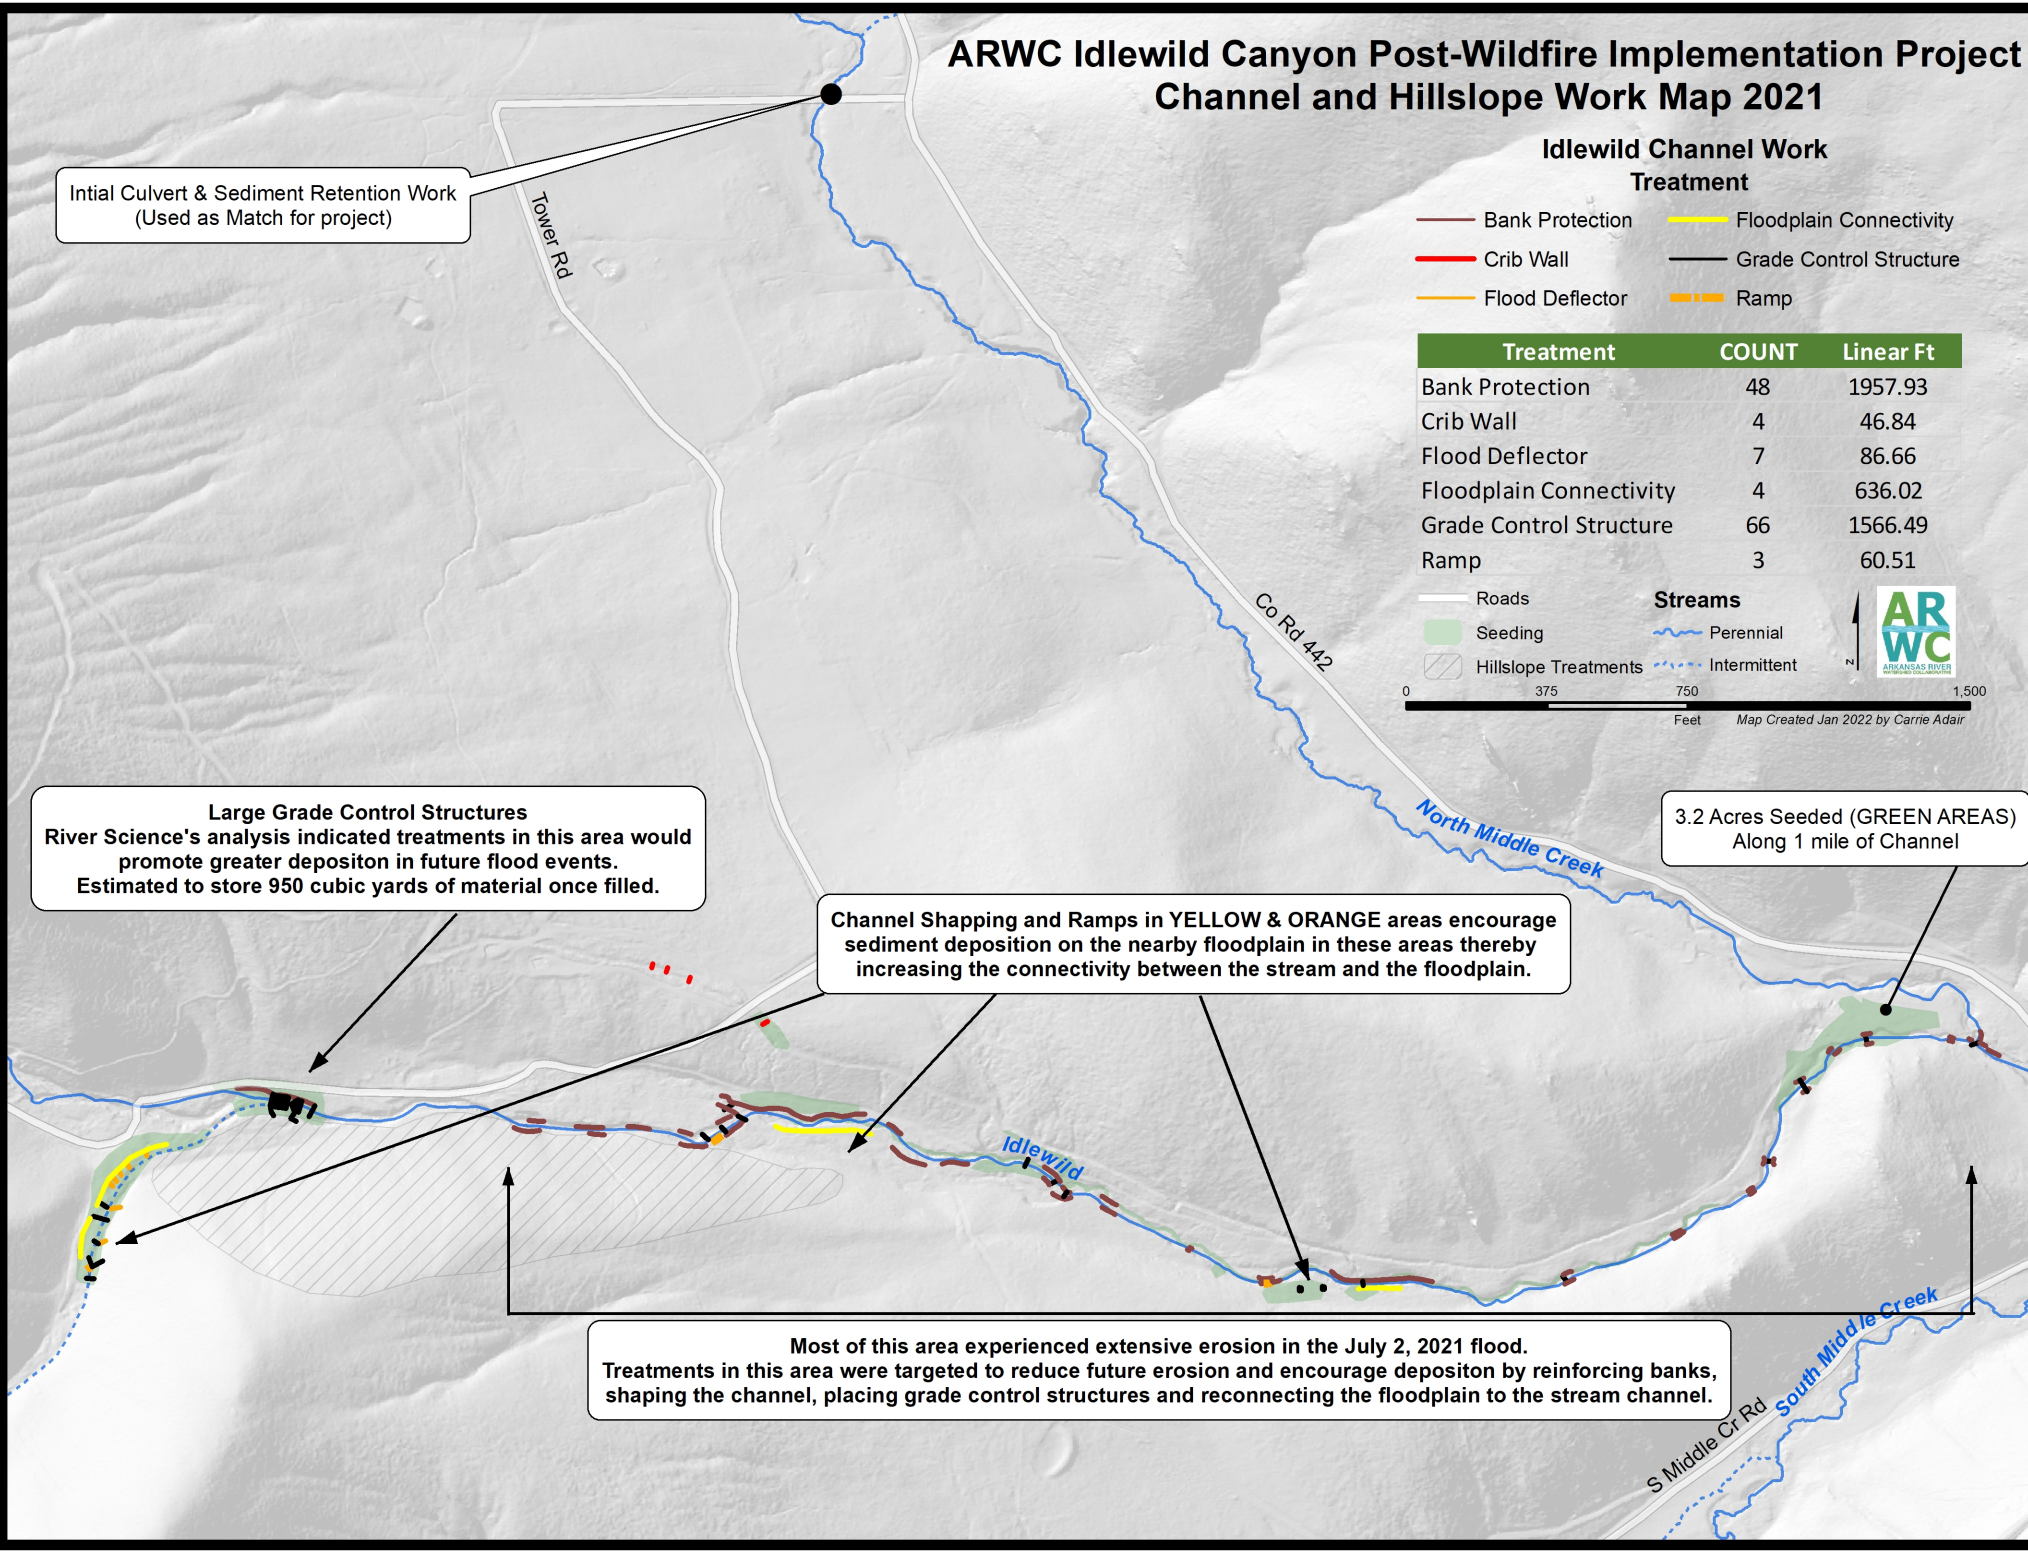
Large Grade Control Structures
 River Science's analysis indicated treatments in this area would promote greater deposition in future flood events. Estimated to store 950 cubic yards of material once filled.

Channel Shapping and Ramps in YELLOW & ORANGE areas encourage sediment deposition on the nearby floodplain in these areas thereby increasing the connectivity between the stream and the floodplain.

3.2 Acres Seeded (GREEN AREAS)
 Along 1 mile of Channel

Most of this area experienced extensive erosion in the July 2, 2021 flood. Treatments in this area were targeted to reduce future erosion and encourage deposition by reinforcing banks, shaping the channel, placing grade control structures and reconnecting the floodplain to the stream channel.
